Matchprint Professional Server

**Matchprint Professional Server
System Troubleshooting –06/21/2002**

SUBJECT: Image Quality Black Line Banding with v11.50.3 software

V2.0.3 Installation Instructions

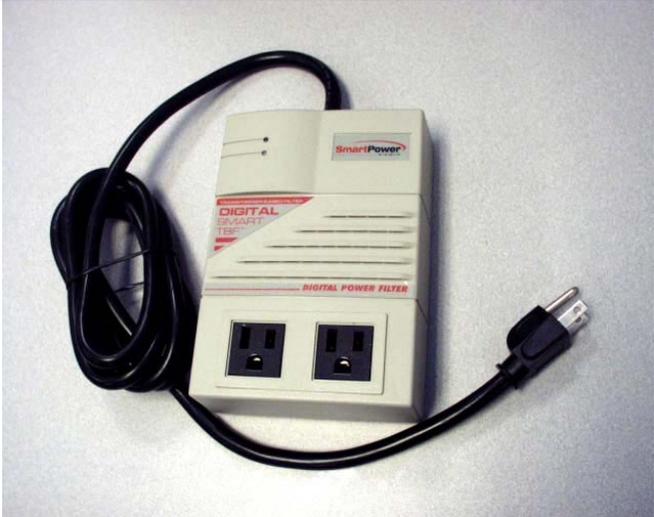
<p>If you have an LP and receive a software error before calibration from the MPS calibration software similar to the following:</p> <p><i>Running SpectroCam version 15 must revert to version 13</i></p>	<p>See process in Calibration troubleshooting area.</p>
<p>A surge protector was shipped with my system, what do I do with it.</p> <p>DO NOT UNDER ANY CIRCUMSTANCES PLUG THE XEROX DOCUCOLOR 12 INTO THE SURGE PROTECTOR.</p>	<div style="text-align: center;">

</div> <ol style="list-style-type: none"> 1. If you have DocuColor 12 CP (scanner) then plug the Server and Monitor into the Surge Protector 2. If you have DocuColor 12 LP (no copier) then plug the Server and a power strip (with monitor and SpectroCam) into the Surge Protector.

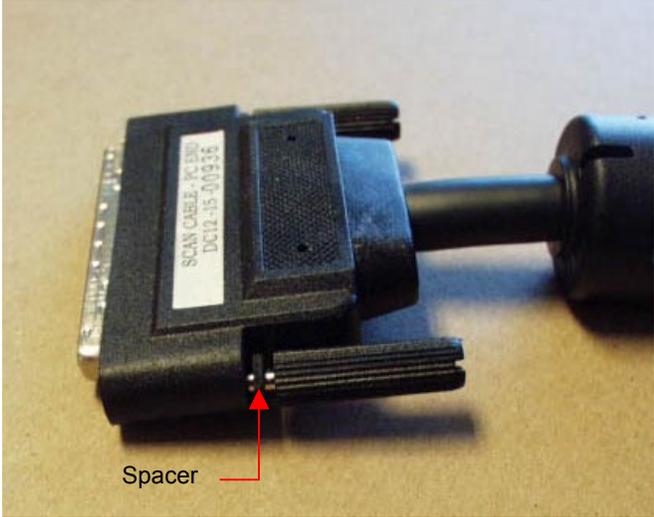
<p>Spacer</p>

Cables	
Problem	Solution
Cables do not appear tight.	<p>Do the cables have the fiber spacer between the black handle of the cable connector thumbscrew and the connector housing?</p>

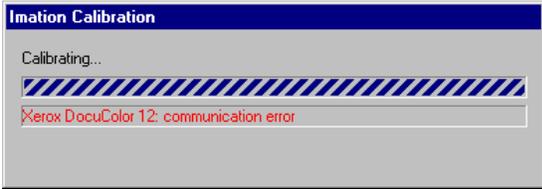
Calibration on DC12 CP with Version 2.0 MPS	
Problem	Solution
<p>"Communication Error" message appears while calibrating or in a calibration pop-up window.</p>

<ol style="list-style-type: none"> 1. The Communication Error message is real-time message labeled incorrectly, if this message lasts up to 15 sec., this is normal. 2. Calibration completes. 3. If customer insists on corrective action send the customer the v2.0.2 patch.
<p>Cannot print 12" x 18" test form.</p>	<ol style="list-style-type: none"> 1. Reboot the MPS server. 2. If still unable to print, restart the DC12. At the RIP Printer menu, delete the DC12 printer, and then re-add the printer. 3. Restart the calibration process
<p>Unable to calibrate 12" x 18" media - calibration does not stop. Having difficulty calibrating 12" x 18" media.</p>	<ol style="list-style-type: none"> 1. Cancel the calibration through the Task Manager (Ctrl + Alt + Del) and select End Task. 2. Power down and Restart the server. 3. Calibrate to normal bond letter size media first. Next, calibrate with 12 x 18 media, when setting the 12 x 18 calibration page on the scanner, offset the page to the right about 1 inch.
