Xerox WorkCentre 7425/7428/7435

Image Quality Defects and Solutions

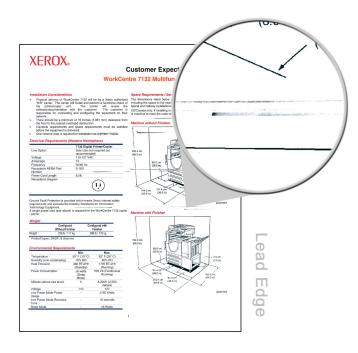
Problem: Streaks appearing from Lead Edge to Trail Edge

Solution: Replace the Transfer Belt Cleaner
