Xerox DocuPrint IPS Messages Guide

Version 7.1
August 2000
721P88950

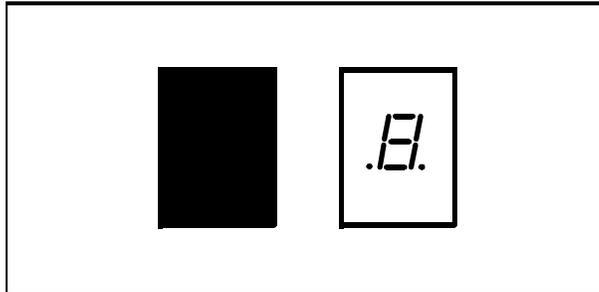
LED code number

The LED code number on the HCU indicate various software states, system faults, and microcode faults, depending on whether:

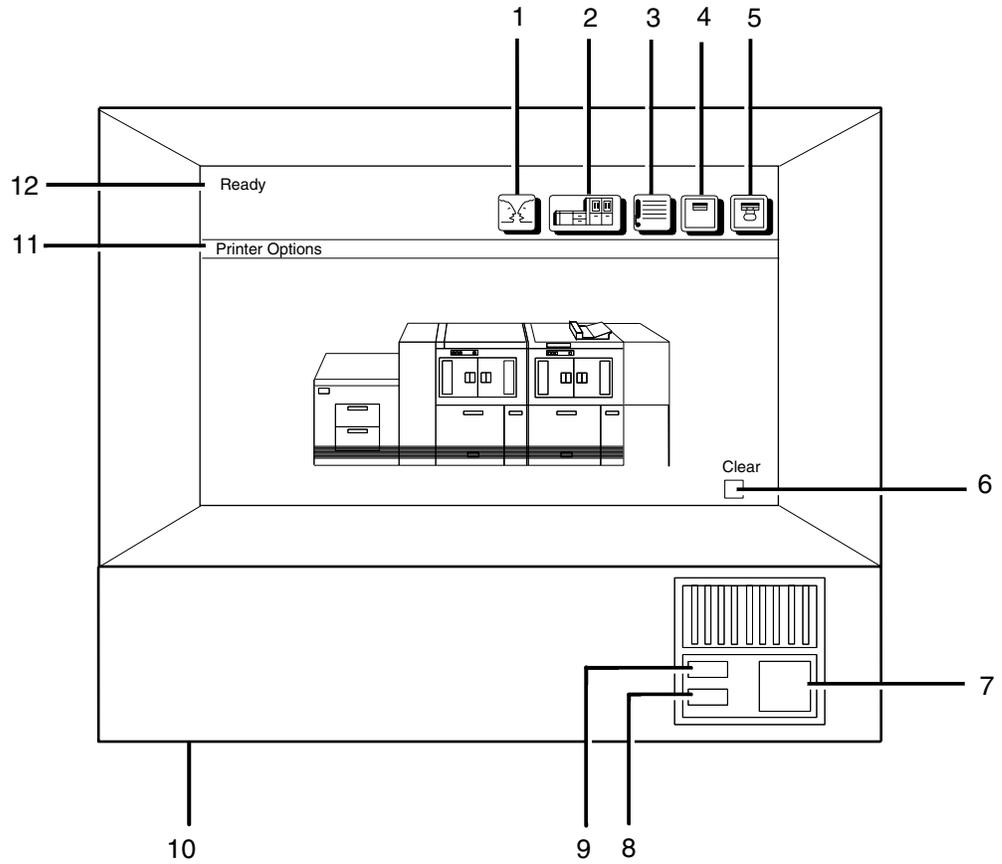
Figure 2-1. **Printer control console**

- 1 Language icon**
- 2 Printer icon**
- 3 Fault List icon**
- 4 Tools icon**
- 5 Guarded Tools icon**
- 6 Clear button**
- 7 Continue button**
- 8 Stop button**
- 9 Sample button**
- 10 Brightness control thumbwheel**
- 11 Icon area**
- 12 Message area**
