Xerox® VersaLink® Product Enhancements Document for Version xx.75.11

Description of new features and enhancements to the products specified below.

Release Date: June 11, 2024 dc24rn4204

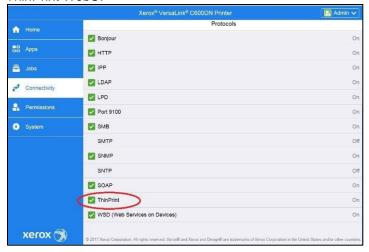
Note: Xerox devices must be equipped with a hard drive or solid-state drive to utilize the ThinPrint feature.

Once the ThinPrint Protocol is enabled, the Admin has access to the settings below. The port must be enabled. The default port number for ThinPrint communication is 4000.
